TOP JOB

Laramie, WY

High Plains Painter

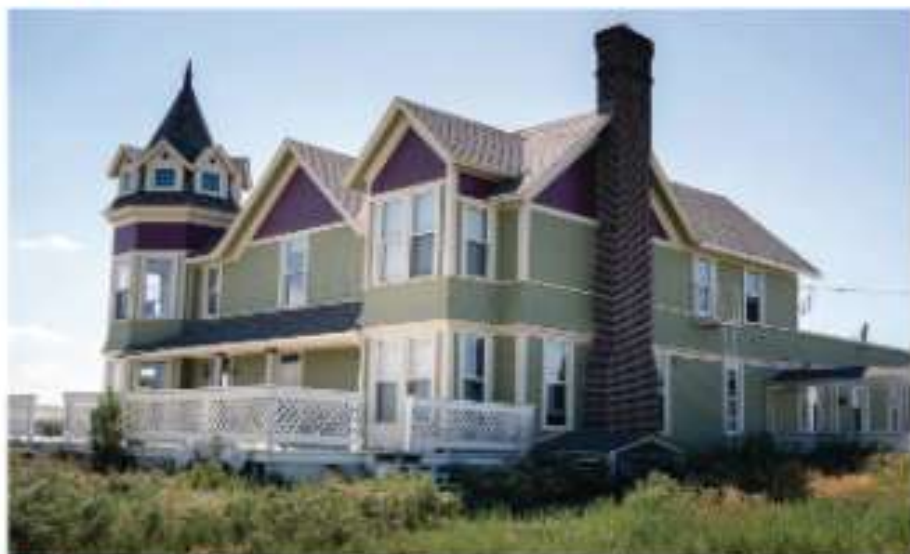
▲ Finished project, with historic colors, eroded over 40 years of neglect.

preserving history matters, it still costs something to bring it back to life. "Our initial quote was to properly strip all the paint off the house to get down to a bare substrate, but due to the customer's budget, that was not going to be possible," said Yarbro. "So instead, we decided to use two coats of PrimeRx Peel Bonding Primer followed by two coats of Duration after thoroughly scraping, caulking and puttying. Project manager Chad Aschoff was put in charge, along with senior painting technicians Michael Choma and Jason Lux. The customer chose beautiful colors to keep with the history of the building, and we decided where to place them."

With all those restrictions in place and accounted for, they set to work. First was to thoroughly scrape all the peeling paint, then apply two full coats of PrimeRx to create a smoother substrate for the top-coat. One of the peaks at this house was 40 feet up, so again, safe practices came into play. As an incentive, the view over the Wyoming plains was incredible, keeping in line with the company name.

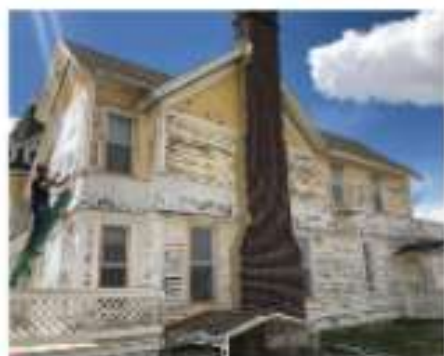
And there it stood, peeling and failing in the harsh Wyoming climate. "In 2018, we were contacted to provide a painting estimate for the entire exterior," said Rob Yarbro, president at Wyoming View Painting. "It was obvious that the house had not been painted in over 20 years." Laramie sits about 7,200 feet above sea level. Winters are harsh, bringing subzero temps and winds of up to 60 mph. And while

▲ Great plains weather ravaged this 1870s exterior.

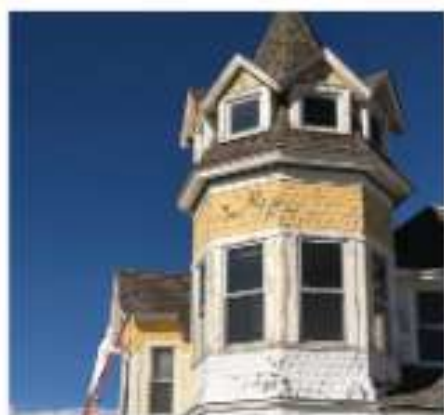
▲ A 40-foot climb greeted painters each morning.

paint all over this building. High peaks and difficult-to-reach areas required a lot of planning with fall arrest placements and lift operations.
